## SERVICE BULLETIN

GREAT LAKES AIRCRAFT

SB-GL12-01R

### HORIZONTAL STABILIZER SPAR INSPECTION

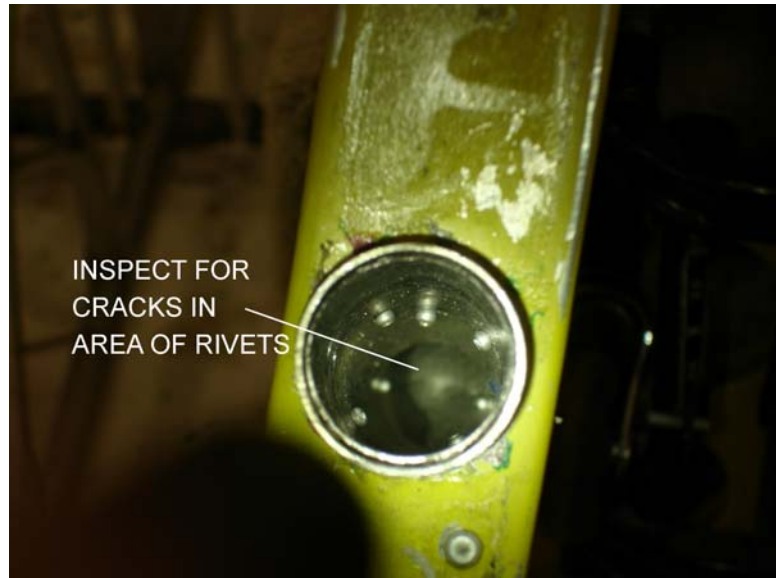
Fig. 5

(e) Clean the area to be inspected using a clean, soft bristle brush or clean lint free cloth. Using a strong light and small mirror, bore scope or remote inspection camera, inspect the inside of the front and rear spar tubes of both left and right stabilizers for cracks. Particular attention is to be directed to the area adjacent to the rivets 3 ½ to 4 ¼ inches in from the end of the tube (see Fig. 5).

- B. If the inspection reveals any cracks in either spar, the stabilizer is not airworthy. Repairs must be accomplished before further flight using one of the following methods:
- (a) Install a new P/N 10102-1 Stabilizer Front Spar Assembly and/or P/N 63219-11 Rear Beam (Spar) Assembly as needed.
  - (b) Replace the defective stabilizer with a new Stabilizer Frame Assembly P/N 63219.
  - (c) Replace the defective stabilizer with a serviceable unit having an 8130-3 Airworthiness Release Certificate stating in Block 13 that SB-GL12-01R has been complied with.
