TO: ALL OWNERS AND OPERATORS OF CLASSIC WACO YMF-5 AIRCRAFT

SUBJECT: CORROSION OF STAINLESS STEEL FLYING WIRES

Classic Aircraft Corporation

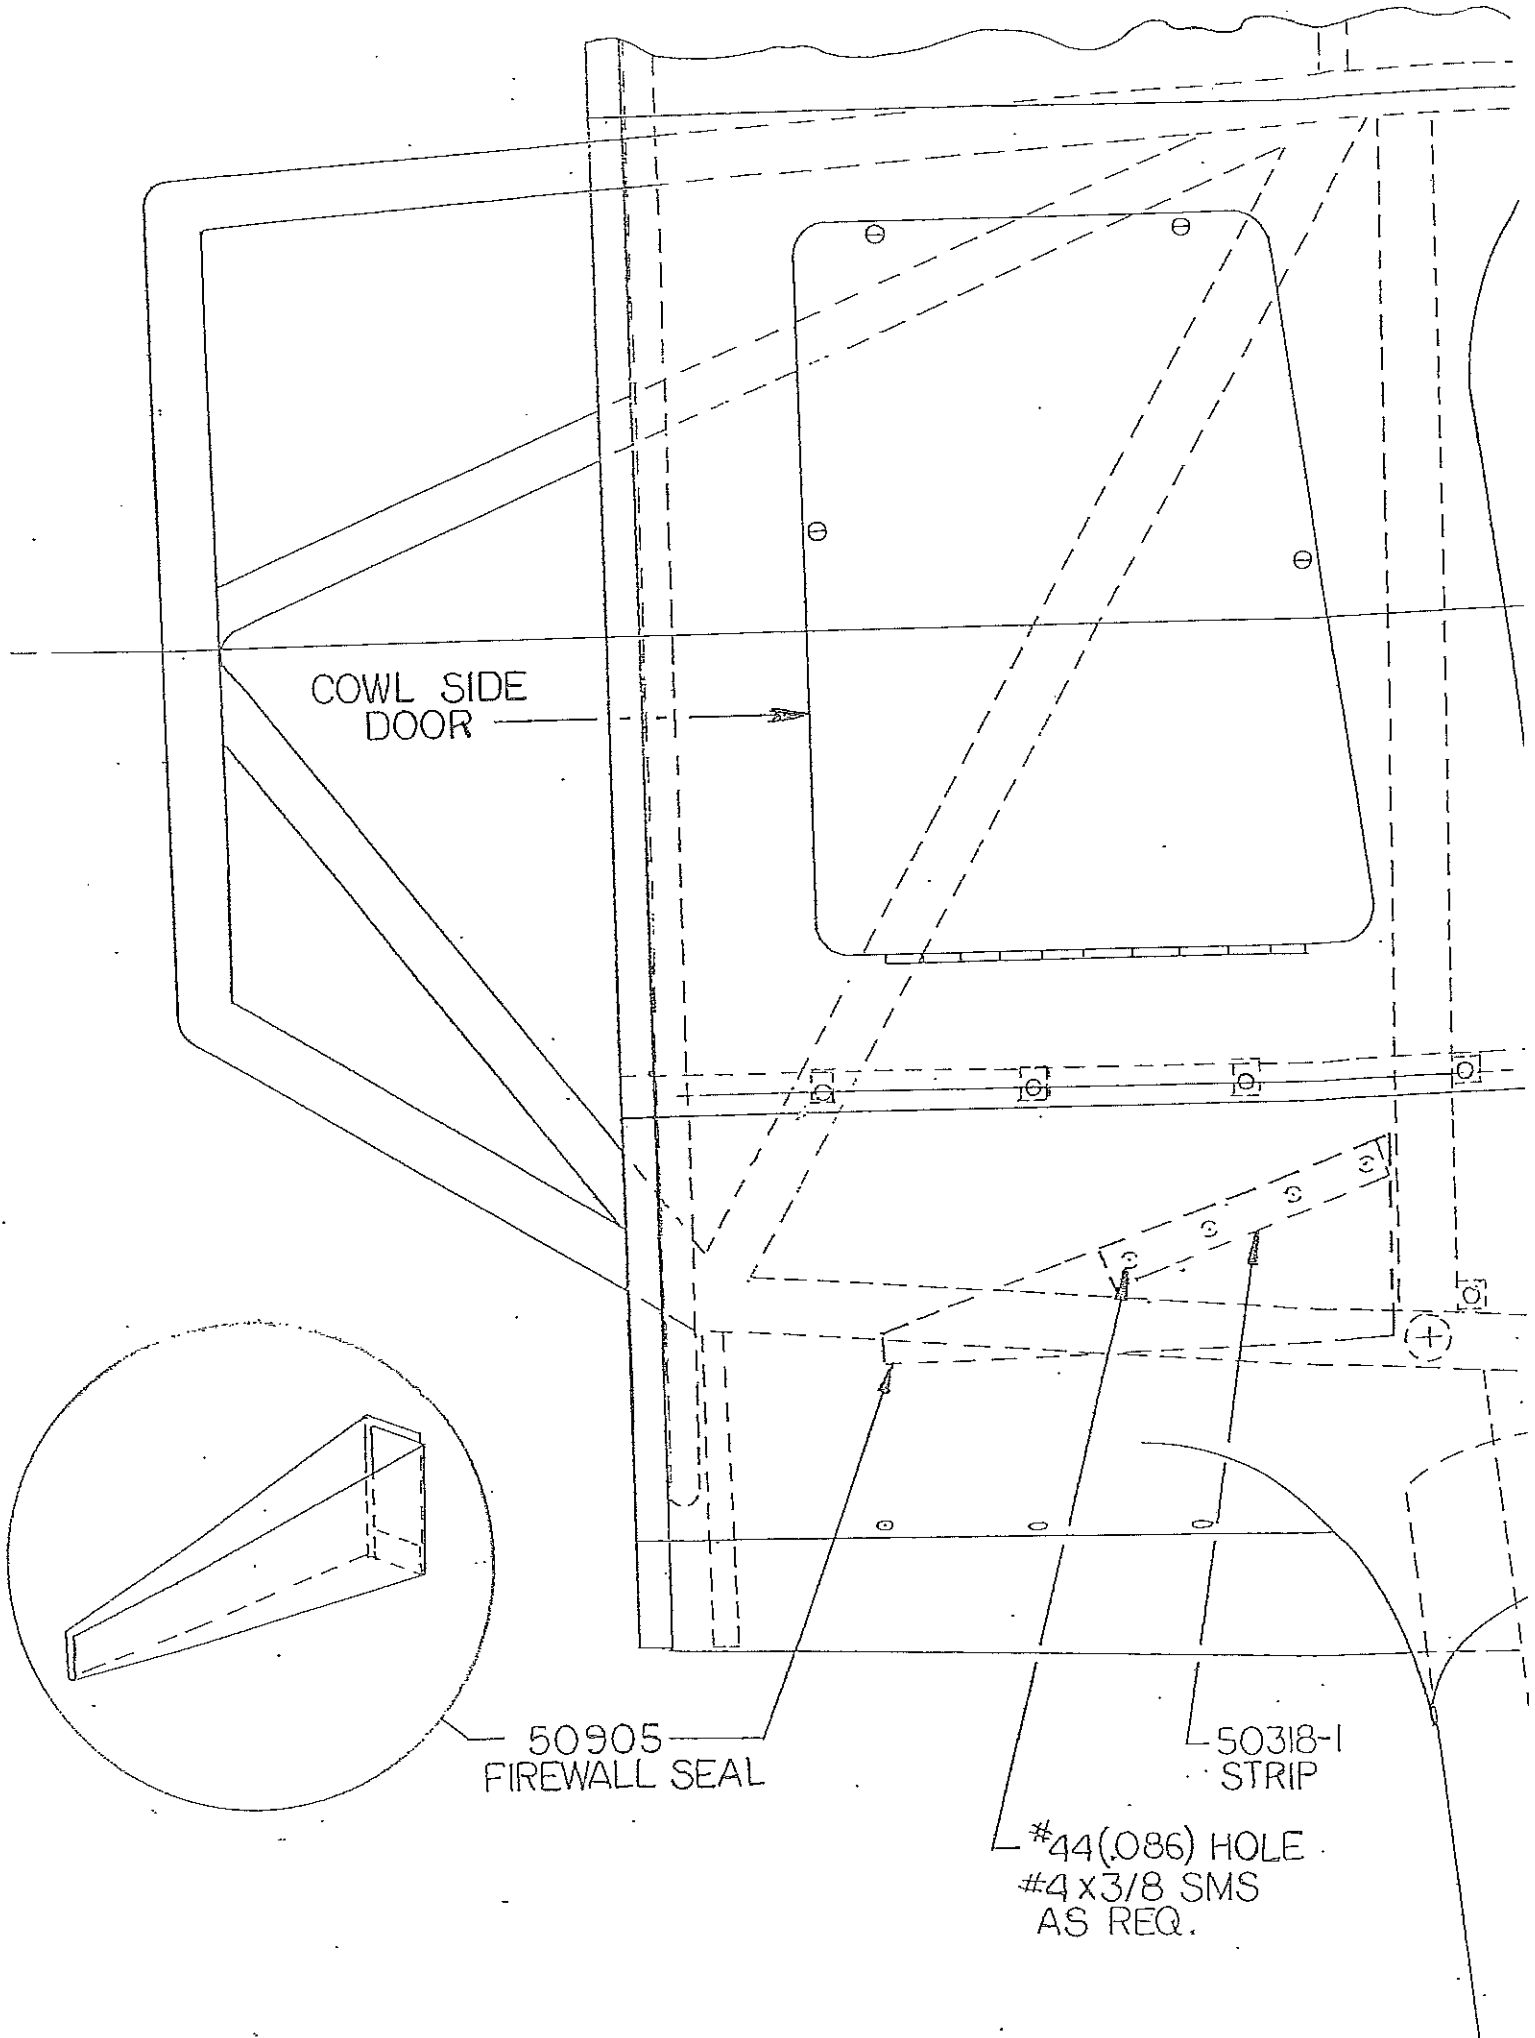
The purpose of this firewall seal is to stop the flow of warm air from the area forward of the firewall back through the landing gear fairing to the cockpit area. The opening to be sealed is located at the forward end of the landing gear fairing and can be seen by opening the cowl side door and looking down and back through the door opening. Notice that the opening is widest at the back and tapers to a point at the front.

Fold the baffle fabric seal to form a triangular shaped open top box and slide into place with the heel of the box against the rear firewall and the point forward. Push the point down far enough to completely close the opening into the fairing. When the seal is properly positioned, cement the top edge and rear tabs of the seal to the firewall only, using 3M #8046 adhesive. When the cement has set, secure the inboard upper edge of the seal to the firewall with the 50318-1 strip, attaching it with #4 x 3/8 sheet metal screws as shown on the attached sketch. It may be necessary to trim the length of the strip to fit. Securing the seal only to the firewall allows removing the belly skin and fairings without disturbing the seal installation.

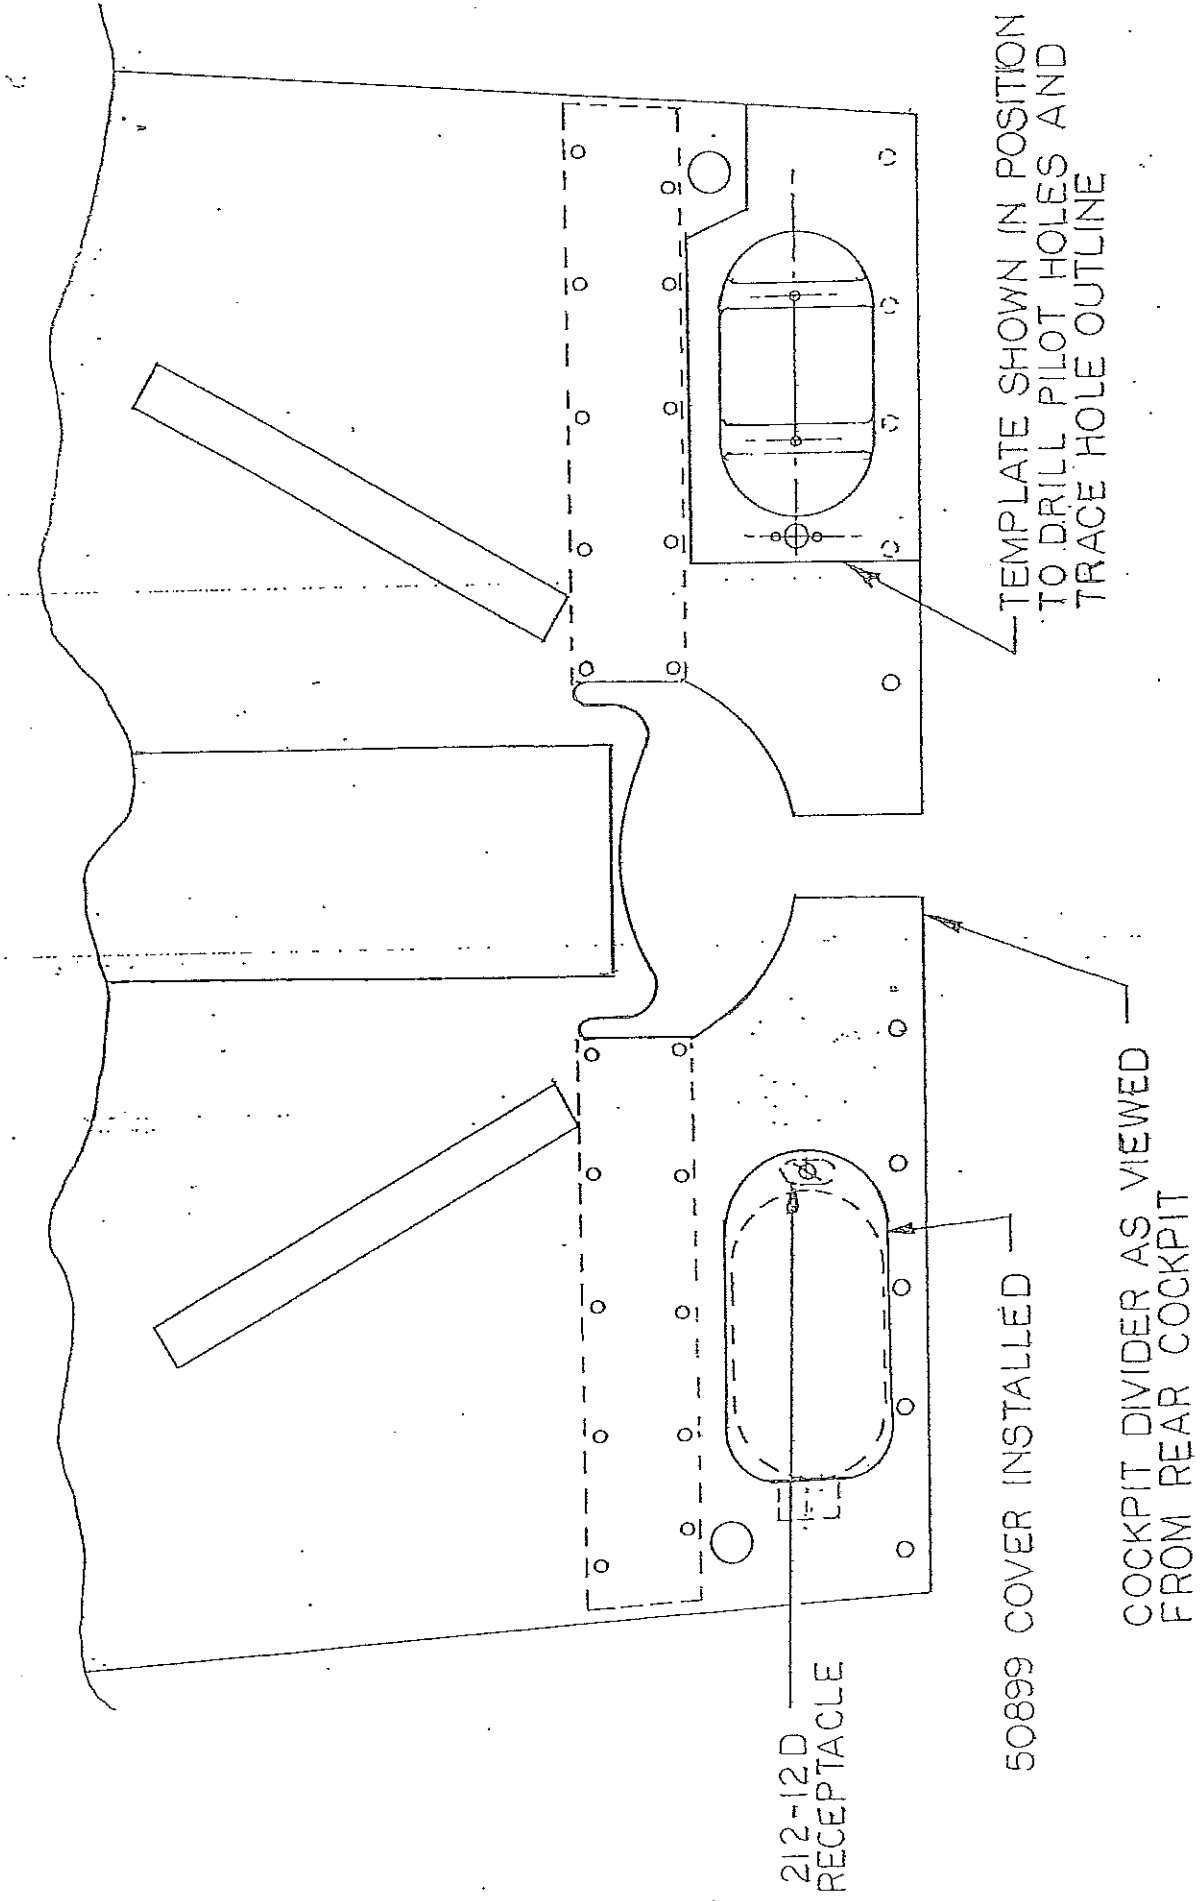
SKETCH 50097M

The purpose of this modification is to provide a route for air to flow between the cockpits through the cockpit divider thus venting both cockpits. The modification consists of adding a vent hole in both lower corners of the cockpit divider panel just forward of the pilot's rudder pedals. This work can be accomplished from the rear cockpit by lowering the seat to the bottom position and removing the seat bottom cushion. The rudder pedals can be tied back to provide more working space.

Locate the template on the lower outboard corner of the cockpit divider as shown on attached sketch 50097M. Using a #40 drill, drill one pilot hole and secure template with a cleco. Then drill remaining pilot holes and trace hole outline. Do the same to the other side of the divider. Enlarge the Camloc center hole to 1/2 inch. Enlarge the vent pilot holes to match the chassis punch to be used. Use the chassis punch to punch the end radius on each end of the vent holes. Route out the remaining material and deburr to complete the hole preparation.

Using two (2) AN426AD3-4 rivets, rivet the 212-12D Camloc receptacle to the forward side of the divider so that the Camloc on the hole cover can be installed from the rear cockpit. The 50899 hole covers can now be installed by inserting the cover tab through the vent hole and engaging the Camloc. Thoroughly clean the area of metal chips, etc., untie the rudder pedals and replace the seat cushion to complete the installation.
