## SERVICE BULLETIN

GREAT LAKES AIRCRAFT

SB-GL12-01R

### HORIZONTAL STABILIZER SPAR INSPECTION

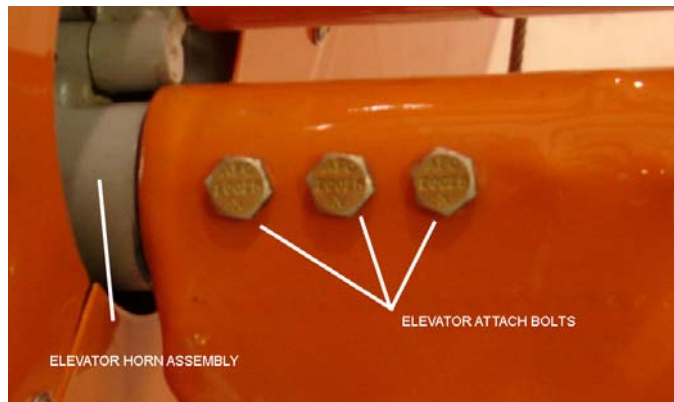
Fig. 1

- A. Conduct a visual inspection of the inside of both horizontal stabilizer front and rear spars at the inboard end attach fitting. This inspection can be accomplished without removing the covering using the following procedure:
1. Uninstall left and right elevators by removing the three AN3-16A elevator attach bolts securing each elevator to the elevator horn assembly (see fig. 1) and sliding the elevator outboard until disengaged from the hinge pins and the elevator horn assembly.

Re-install the left and right elevator assemblies by sliding the elevator over the elevator horn assembly and engaging the hinge pins. Install the three AN3-16A elevator attach bolts (Fig 1).

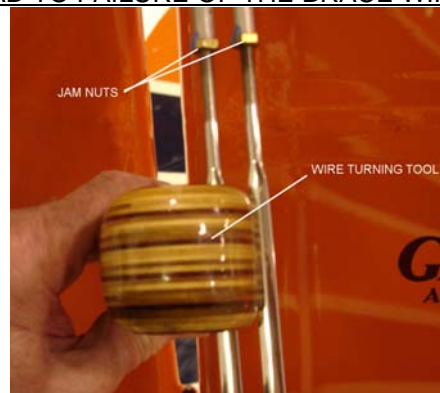
Fig. 2

2. Remove left and right horizontal stabilizers as follows:
  - (a) Relieve tension on the upper stabilizer brace wires on both sides of the vertical fin by first loosening the jam nuts at each end of each of the four streamline wires. Using a tool designed for adjusting streamline wires, engage the flattened section of the wire as near to the round section as possible at each end and turn to loosen each wire 4 full turns. **IMPORTANT: DO NOT USE ANY TOOL THAT WILL MARK OR SCRATCH THE SURFACE OF THE WIRE. DOING SO CAN LEAD TO FAILURE OF THE BRACE WIRE.** (See fig. 2)

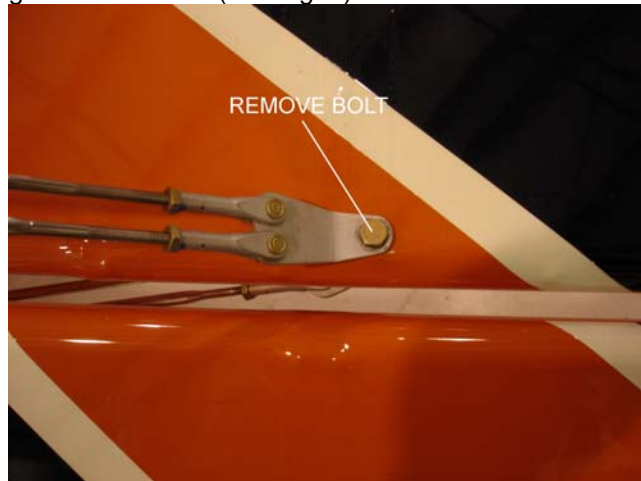
Fig. 3

(b) Remove the AN4 bolt through the stabilizer rear spar securing the brace wire fitting to the stabilizer (see Fig. 3).

Attach the 10116-1 brace wire fitting (Fig 3) to the stabilizer rear spar tightening the AN4 bolt until the brace wire lug will not turn by hand then loosen the nut  $\frac{3}{4}$  turn. The 10116-1 brace wire lug should now be free to move by hand. Re-install the inspection cover over the front stabilizer attach bolts top and bottom.

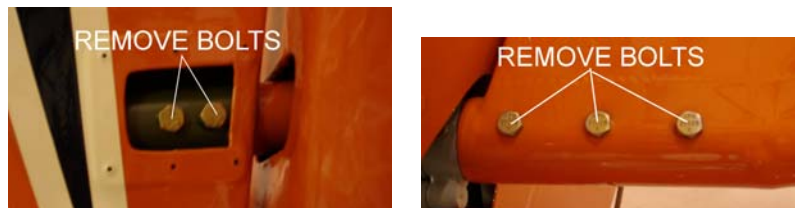
Fig 4

(c) Uninstall the right horizontal stabilizer by removing the inspection cover over front stabilizer attach bolts top and bottom. Remove the two (2) AN4-17A bolts securing the right front stabilizer spar to the stabilizer center front beam. Remove the three (3) AN3-16A bolts securing the right rear stabilizer spar to the stabilizer center rear beam. (see Fig. 4) Slide the right stabilizer outboard disengaging it from the front and rear center beams. Mark the position of the center beam tubes extending from the fuselage relative to the stabilizer attach fittings to insure correct hole alignment during re-assembly.

Re-install the left and right stabilizers aligning the reference marks made during disassembly taking care that the bolt holes in the stabilizer correspond to the holes in the center beam. Reinstall the two AN4-17 bolts in the front spars and the three AN3-16A bolts in the rear spars (Fig 4).

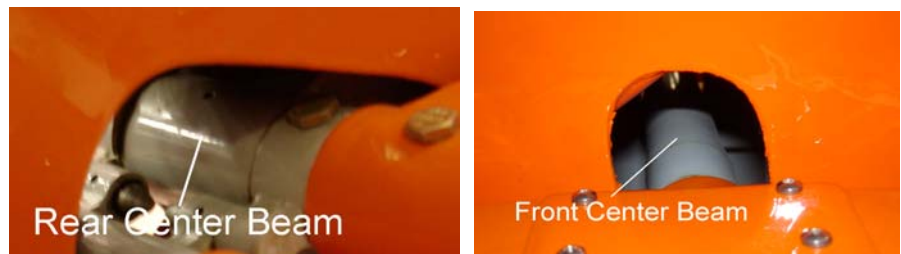
Fig. 6

- C. Prior to re-installing the stabilizers, inspect the condition of the front and rear Center Beam Assemblies to insure that they are free to rotate and are well lubricated with WD-40 (Ref. page II-1 of the Great Lakes Maintenance and Rigging Manual Model 2T-1A). (See Fig 6)
